# **8 March 2010 Elazığ-Kovancılar (Turkey) Earthquake: Observations on Ground Motions and Building Damage**

Sinan Akkar<sup>1</sup>, Alper Aldemir<sup>1</sup>, Aysegul Askan<sup>1</sup>, Sadık Bakır<sup>1</sup>, Erdem Canbay<sup>1</sup>, Ozan Demirel<sup>1</sup>, Altug Erberik<sup>1</sup>, Zeynep Gülerce<sup>1</sup>, Polat Gülkan<sup>1</sup>, Erol Kalkan<sup>2</sup>, Surya Prakash<sup>3</sup>, Abdullah Sandıkkaya<sup>1</sup>, Volkan Sevilgen<sup>2</sup>, Beliz Ugurhan<sup>1</sup>, Emrah Yenier<sup>1</sup>

- 1 Earthquake Engineering Research Center, Middle East Technical University, 06531 Ankara, Turkey
- 2 US Geological Survey, Menlo Park, CA 94025
- 3 National Institute of Disaster Management, New Delhi 110-002, India

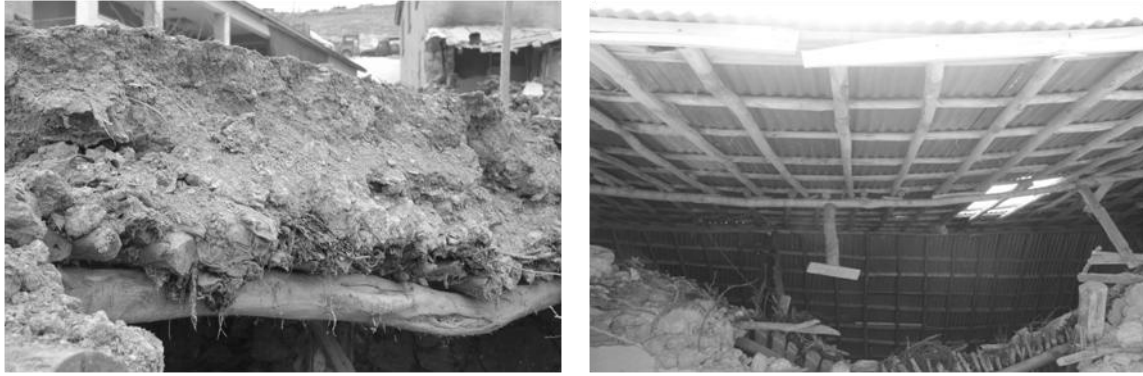
Rural masonry buildings are characterized in two different ways according to the roof material used. First one is heavy condensed soil which is laid over the slab supported by wooden logs. Second one is light metal sheets which are supported by wooden girders and columns (Figure 6).

**Figure 6. a) Heavy earthen roofs b) Light sheet metal roof supported by wooden logs**

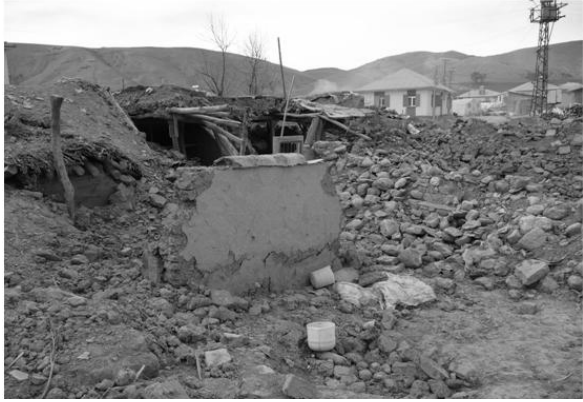
(a)

Type-I buildings constitute the most vulnerable structural system among others. Many such buildings have collapsed in past earthquakes resulting in loss of lives. Thickness of the condensed soil at the roof is in between 30-50 cm. Such heavy roofs induce large inertial forces during earthquake which result in high stresses on low strength walls. Roof cave-in becomes a death trap for the people inside the building (Figure 7.a). EMS vulnerability class A can be assigned to these type of buildings.

**Figure 7.** Local buildings classified according to structural typology. Examples of **a)** Type-I, **b)** Type-II, **c)** Type-III and **d)** Type-IV buildings

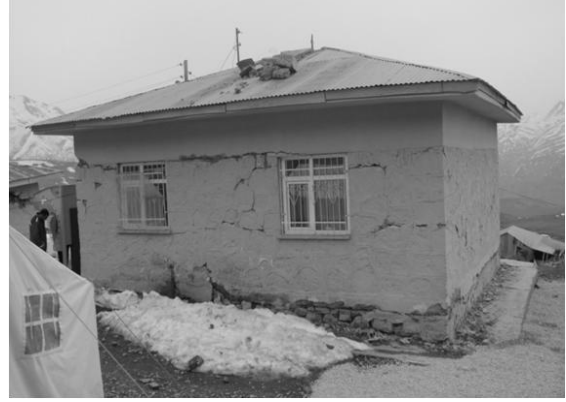
(b)

Type-II buildings are more resistant to earthquake effects than Type-I buildings due to their lighter roofs, properly placed horizontal bond beams, relatively better corner connections and better vertical alignment of openings. This type of buildings is not earthquake resistant but can withstand earthquakes of moderate intensity since some basic rules of thumb have been considered during the construction of these buildings. Therefore, the buildings in this category were observed to experience

some damage during the Elazığ Kovancılar earthquake but total collapse was usually prevented (Figure 7.b). EMS vulnerability class B is assigned to these type of buildings.

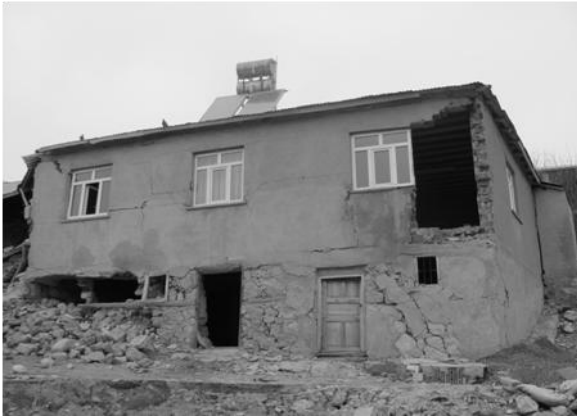
(c)

Type-III buildings are the most complex structural systems which are frequently encountered in the field. Their ground story is often used as barn or for storage. It is generally made of stone, but there are also cases where adobe is used. Second story is used for residential purposes and is generally made of hollow factory brick. The main problem in this type of buildings is the incompatibility of the materials used for different stories and their improper connection to each other. Partial out of plane

collapse of second storey walls is a typical damage pattern for this type of buildings (Figure 7.c). EMS vulnerability class A can be assigned to these type of buildings.

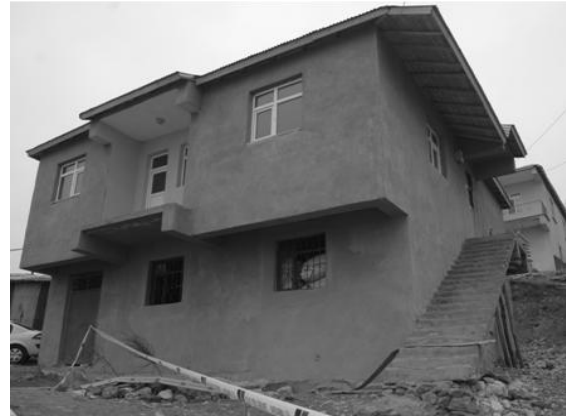
(d)

Type-IV buildings are rarely observed in the field. Reinforced concrete columns, beams and slabs are the load bearing members. Unlike Type-I, -II and -III, rigid diaphragm action is valid for this type of buildings due to stiff concrete slab. However, the material quality is poor and the construction practice does not generally conform to fundamental requirements of earthquake resistant design. It should not be surprising that this type of buildings exhibited an adequate performance with limited damage during such a moderate earthquake (Figure 7.d). EMS vulnerability class C can be assigned to these type of buildings.

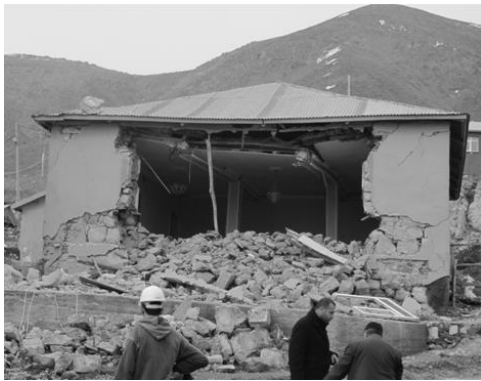
(a)

The failure modes of rural masonry buildings observed in the field are out-of-plane failure of walls and gable end walls, in-plane failure of walls, total or partial collapse of the buildings due to the absence of structural integrity and collapse of the roof. Out-of-plane failure of walls and gable end walls can easily be inferred from the site observations that this type of failure mode is frequently encountered. The main causes of this failure mode are stability problems that arise from large unsupported wall lengths in the absence of lateral supporting walls, (Figure 8.a), poor wall-to-floor connections (Figure 8.b) and poor wall-to-wall connections (Figure 8.c). In the absence of connecting units and proper detailing at the connections of perpendicular walls, the walls are separated from each other, behaving like single walls that are weak in the out-of-plane direction. Collapse of gable end wall was also encountered during field investigations (Figure 8.d).

**Figure 8.** Out of plane failures of walls due to **a)** large unsupported wall length, **b)** poor wall-to-wall connection, **c)** poor wall-to-floor connection, **d)** unstable gable end wall

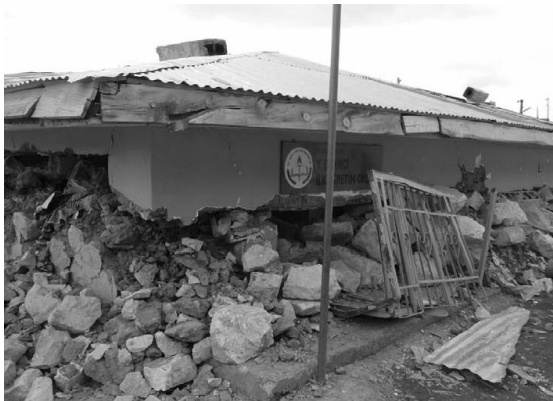
(a)

Primary school buildings in the affected villages were stone masonry buildings of Type-I and –II and they experienced significant damage during the earthquake. The school building in Yukarı Demirci collapsed during the earthquake. A closer look at the collapsed school building revealed that there was a ring beam at the roof level of the building which was supposed to be made of reinforced concrete, but it was “reinforced stone”, i.e. pieces of crushed stone was filled inside the reinforcement cage with inadequate amount of mortar to hold the pieces together and to fill the spaces (Figure 9). Primary school buildings in other two villages were also severely damaged. Hence, it was fortunate that the earthquake did not happen during day-time when the students were studying in their classes.

**Figure 9.** Collapsed stone masonry school building in Yukarı Demirci village **a)** exterior view,  
**b)** Closer look at the reinforced stone ring beam at the roof level

The engineering reconnaissance showed that despite important advances toward achievement of seismic safety elsewhere in the country, rural areas with low economic status still lack adequate life safety. Of particular concern is the poor performance of school buildings, the most widely used facilities. An inspection program for school buildings similar to those that were damaged beyond repair must be immediately undertaken.

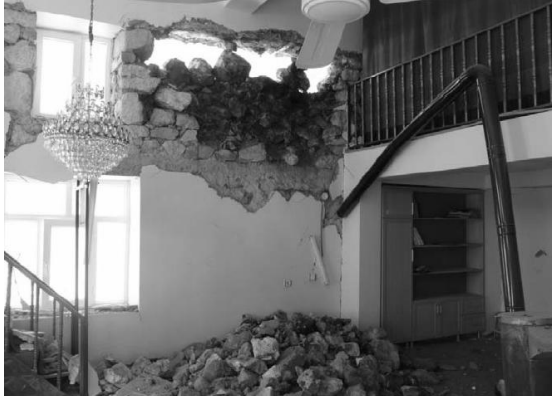
(a)

Mosques and minarets were also damaged in the villages during the earthquake. Figure 10.a shows the interior view of the mosque in Yukarı Kanatlı village. It was a stone masonry building of Type-B with out-of-plane damage to its exterior walls. Minarets in three of the villages were also destroyed (Figure 10.b).

**Figure 10.** a) Interior view of the damaged mosque in Yukarı Kanatlı village, b) damaged minaret in Yukarı Demirci village.

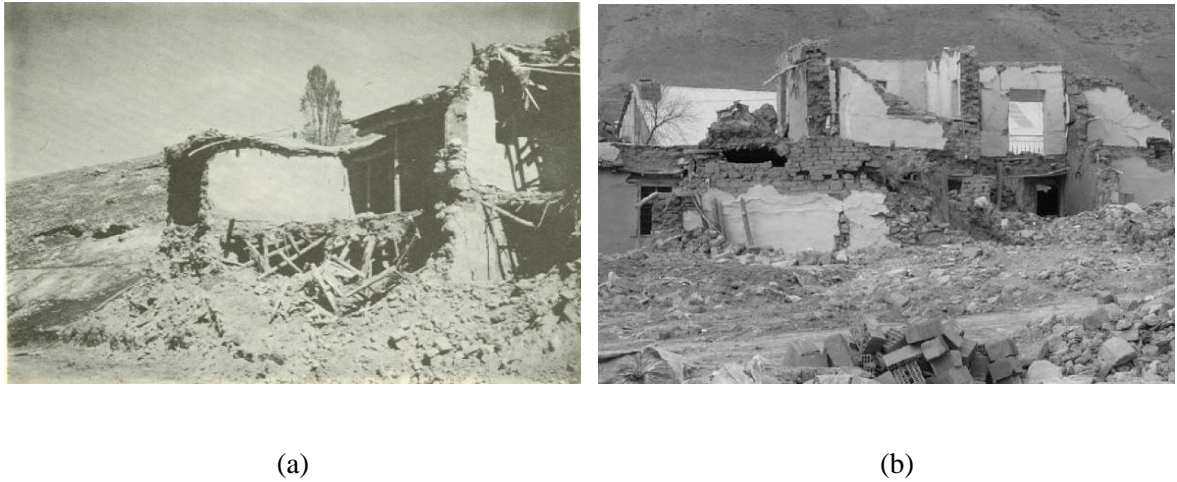
A final comment on building practices is illustrated vividly in Figure 11 that shows damage to the type of rural buildings that have been described in this report. With little differences in the way dwellings are built (usually by their owners) between 1977 and 2010, there is also little difference in their seismic capacities. Minor improvement in details would have served to avoid collapses and the resulting losses of life.

**Figure 11.** Photos taken from collapsed rural masonry buildings **a)** during the Elazığ Palu earthquake in 1977 **b)** Elazığ Kovancılar earthquake in 2010
